SERVICE BULLETIN

MODEL: TS-930 S	NO.: 0045	DATE:																																		
VON/FROM/DE: TRIO-KENWOOD COMMUNICATIONS Division of TRIO KENWOOD ELECTRONICS GMBH		D	M	Y																																
		21	10	83																																
SUBJECT: Digital Unit through-plated hole defects and their symptoms																																				
CONTENTS: The unit shows symptoms as listed below, when any of the 56 Digital Unit through-plated holes are open. These examples were compiled by Mr. Negishi of the Kanto service center. Make full use of the Material as a technical reference for repair.

TS-930S PC BOARD VIEW

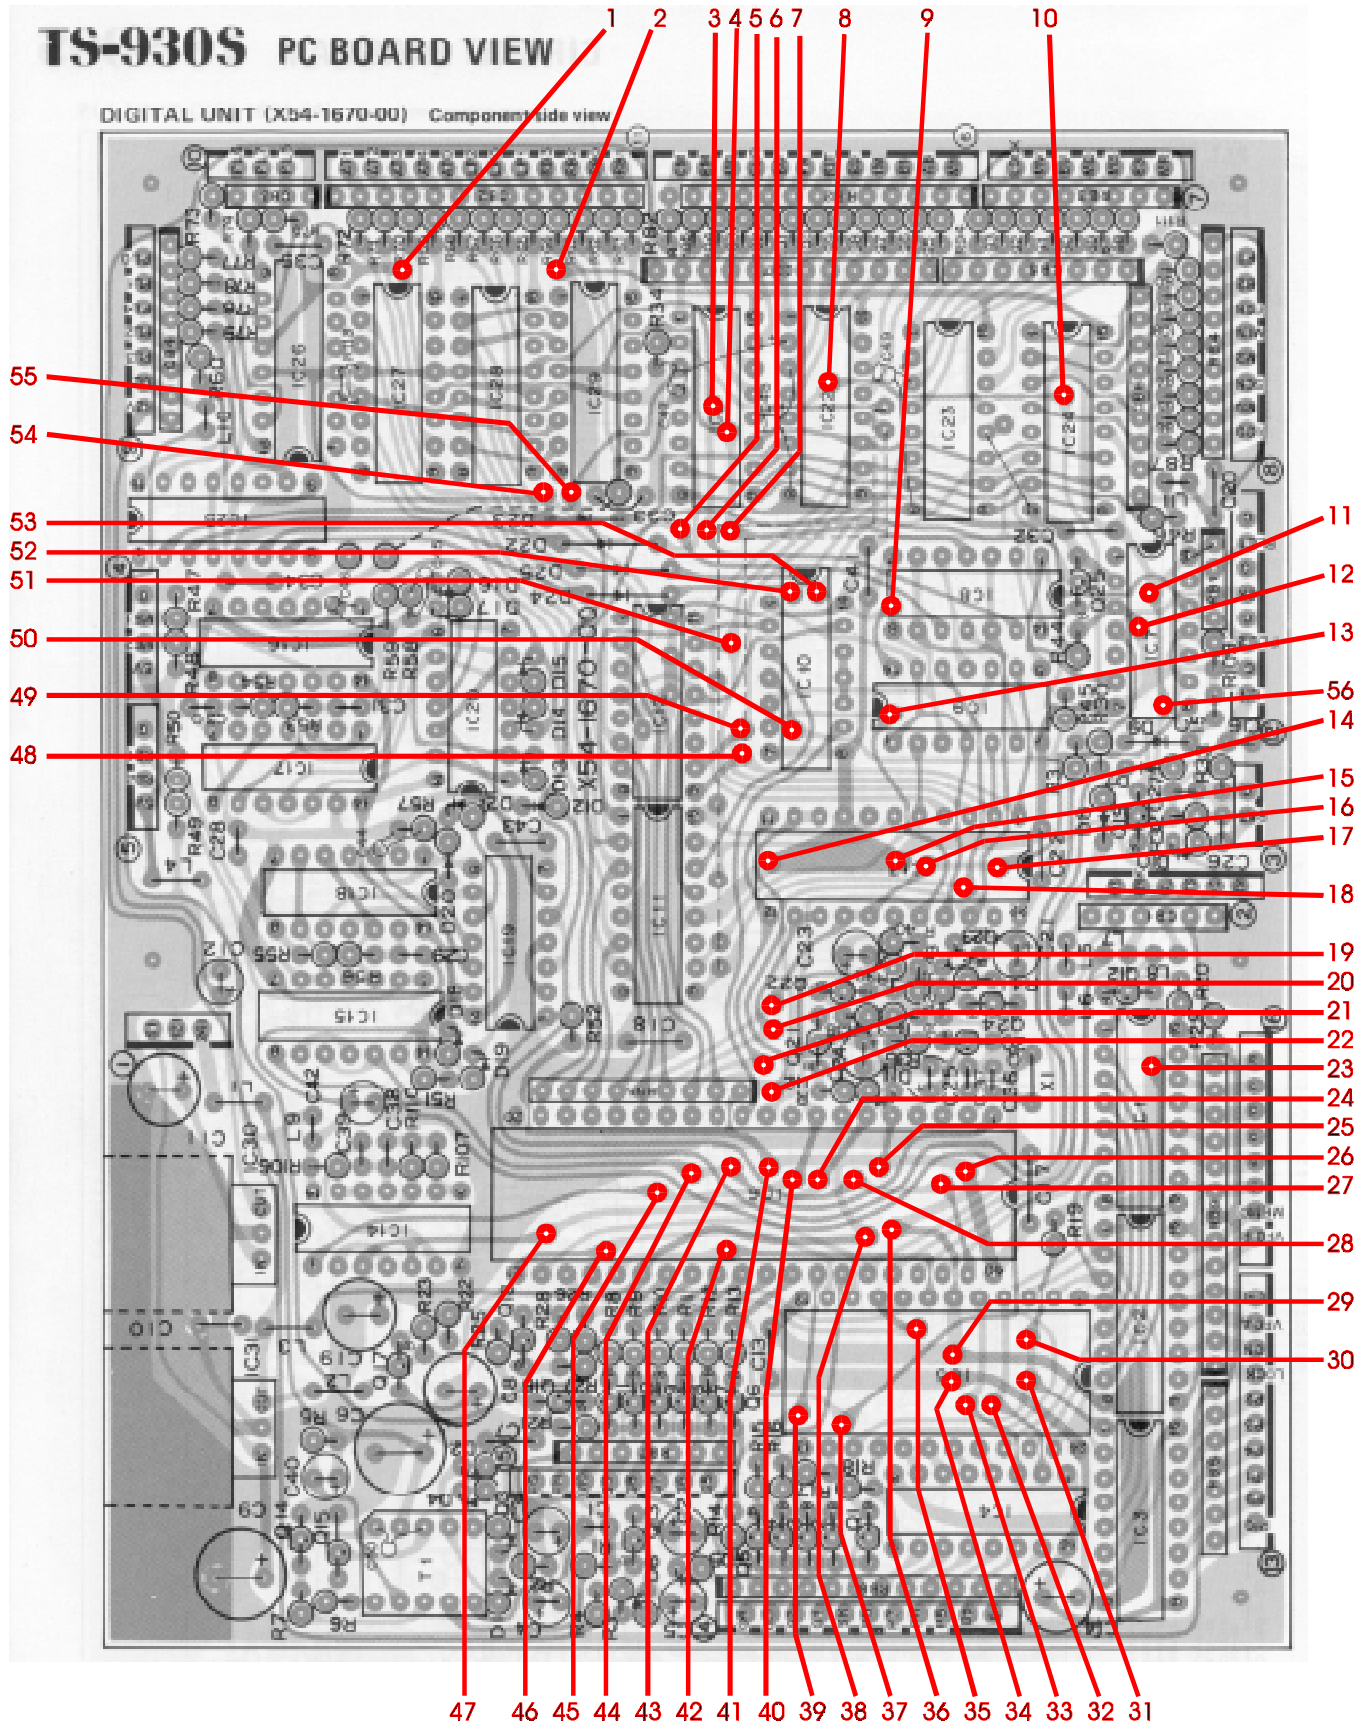
DIGITAL UNIT (X54-1670-00) Component side view
